LENR anomalies in Pd-H₂ systems submitted to LASER stimulation

Ubaldo Mastromatteo

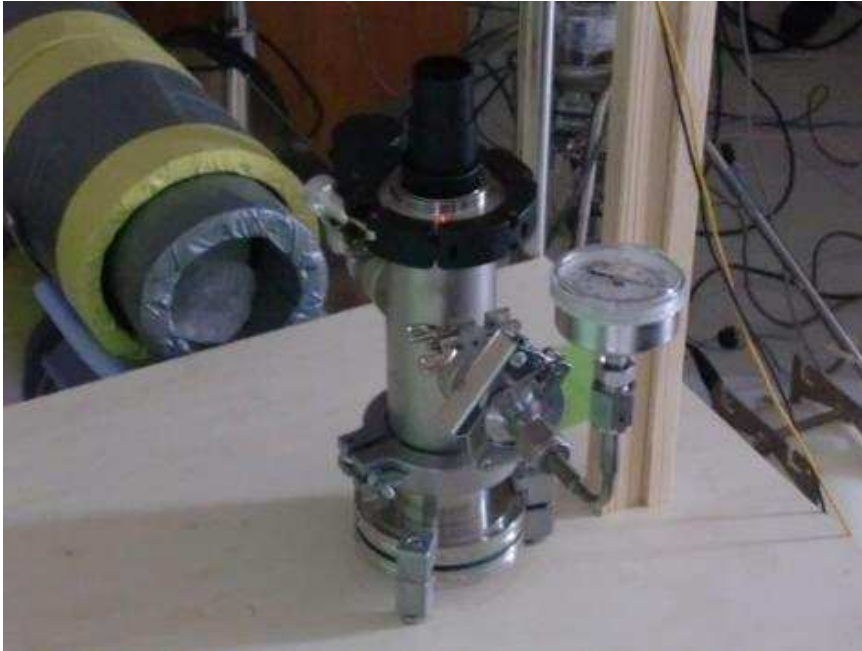
He-Ne LASER experiments reactor and sample

Photos of the reactor and the bottom part where the sample with the Palladium film will be placed

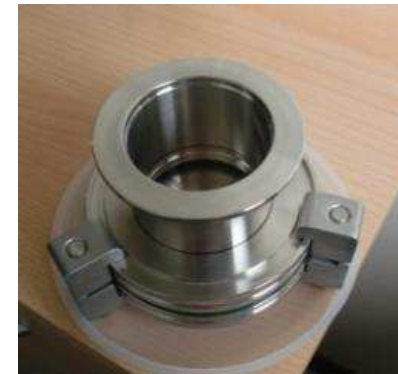
Oxidized silicon chip on which it is deposited a layer of palladium 250 nm thick; the size of the chip is: width 1mm, length 28 mm

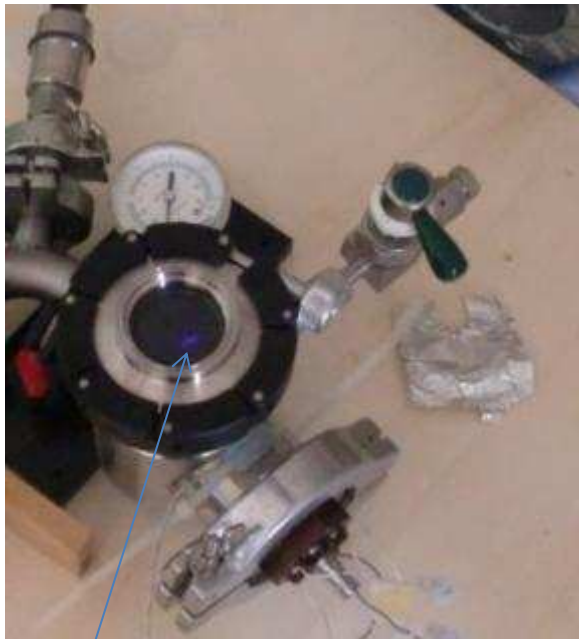
Experimental set up sketch

- Another experiment was conducted on a square silicon chip (1 cm^2) covered with the same thin palladium film (250 nm) of the previous tests, but now irradiated with a solid state LASER, 405 nm, 3 mW, widening the spot of the beam to about 1 cm^2 . After two weeks of irradiation, the sample was extracted and examined by SEM and EDX analysis using an Hitachi TM 3030 system. Also in this case, exploring carefully the surface of the palladium, several cavities have been found on which the EDX analysis was conducted.
